TECHNICAL REPORT S-78-6

# INVESTIGATION OF CONSTRUCTION CONCEPTS FOR PAVEMENTS ACROSS SOFT GROUND

Geotechnical Laboratory  
U. S. Army Engineer Waterways Experiment Station  
P. O. Box 631, Vicksburg, Miss. 39180

July 1978

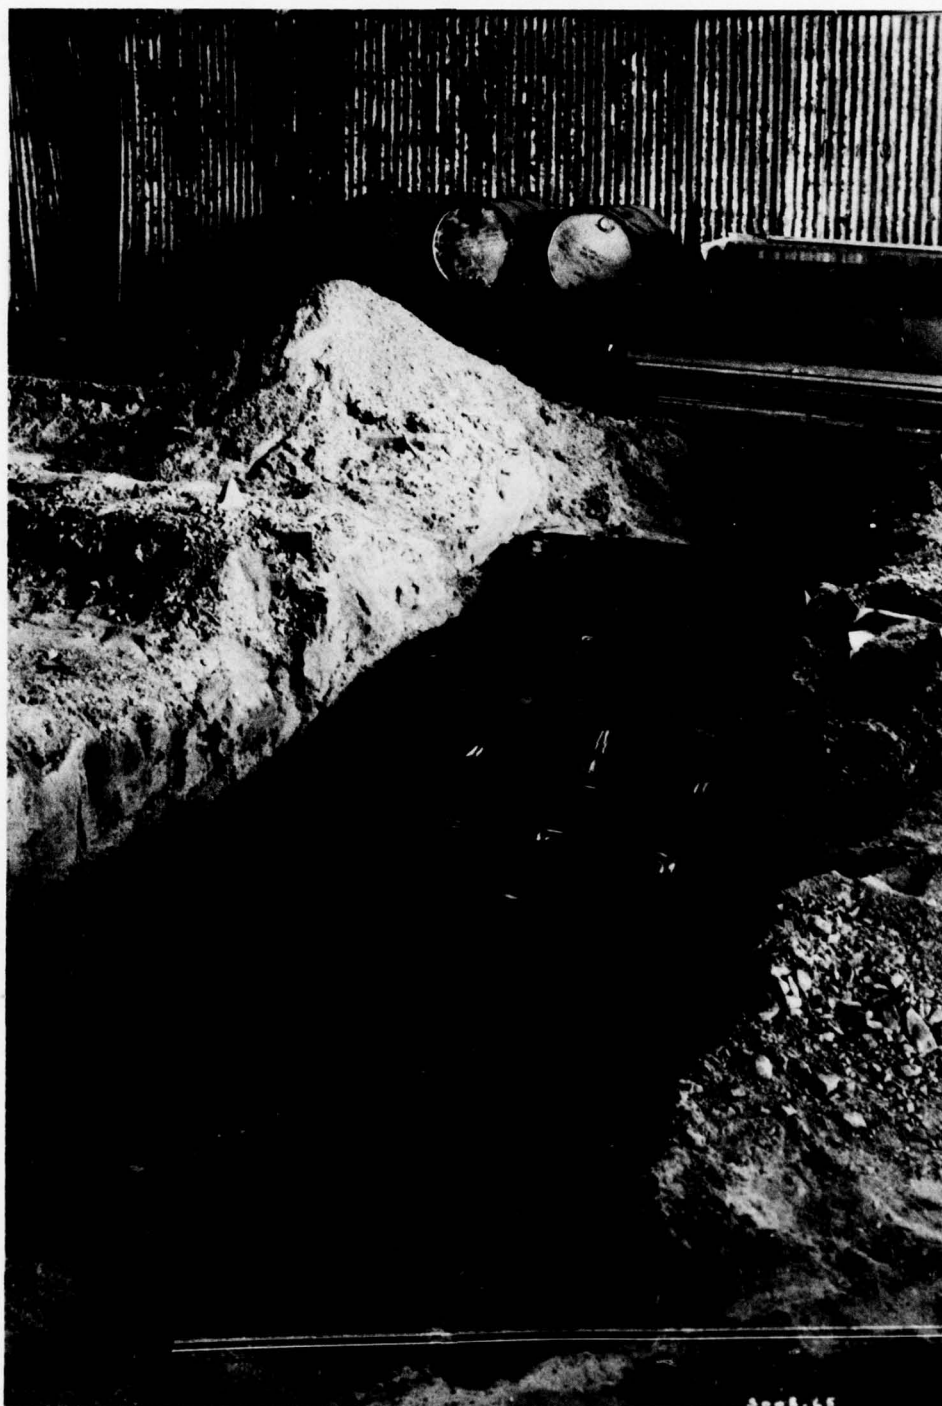
Photo 27. Damaged T-16 membrane in item 4 after 1907 coverages

37. Approximately 3 to 4 in. of sand was displaced from the grid layer inside the wheel paths during traffic. The tops of the grids were bent by traffic as the sand was being displaced (Photo 26). Photo 27 shows the condition of the T-16 membrane after the grid layer was removed. The grids had cut holes in the T-16 membrane at numerous locations. The surface of the subgrade is shown in Photo 28; the rut and upheaval shown are typical to that which occurred in items 1, 2, and 3. Typical cross-section data for this item are presented in Plate 6.

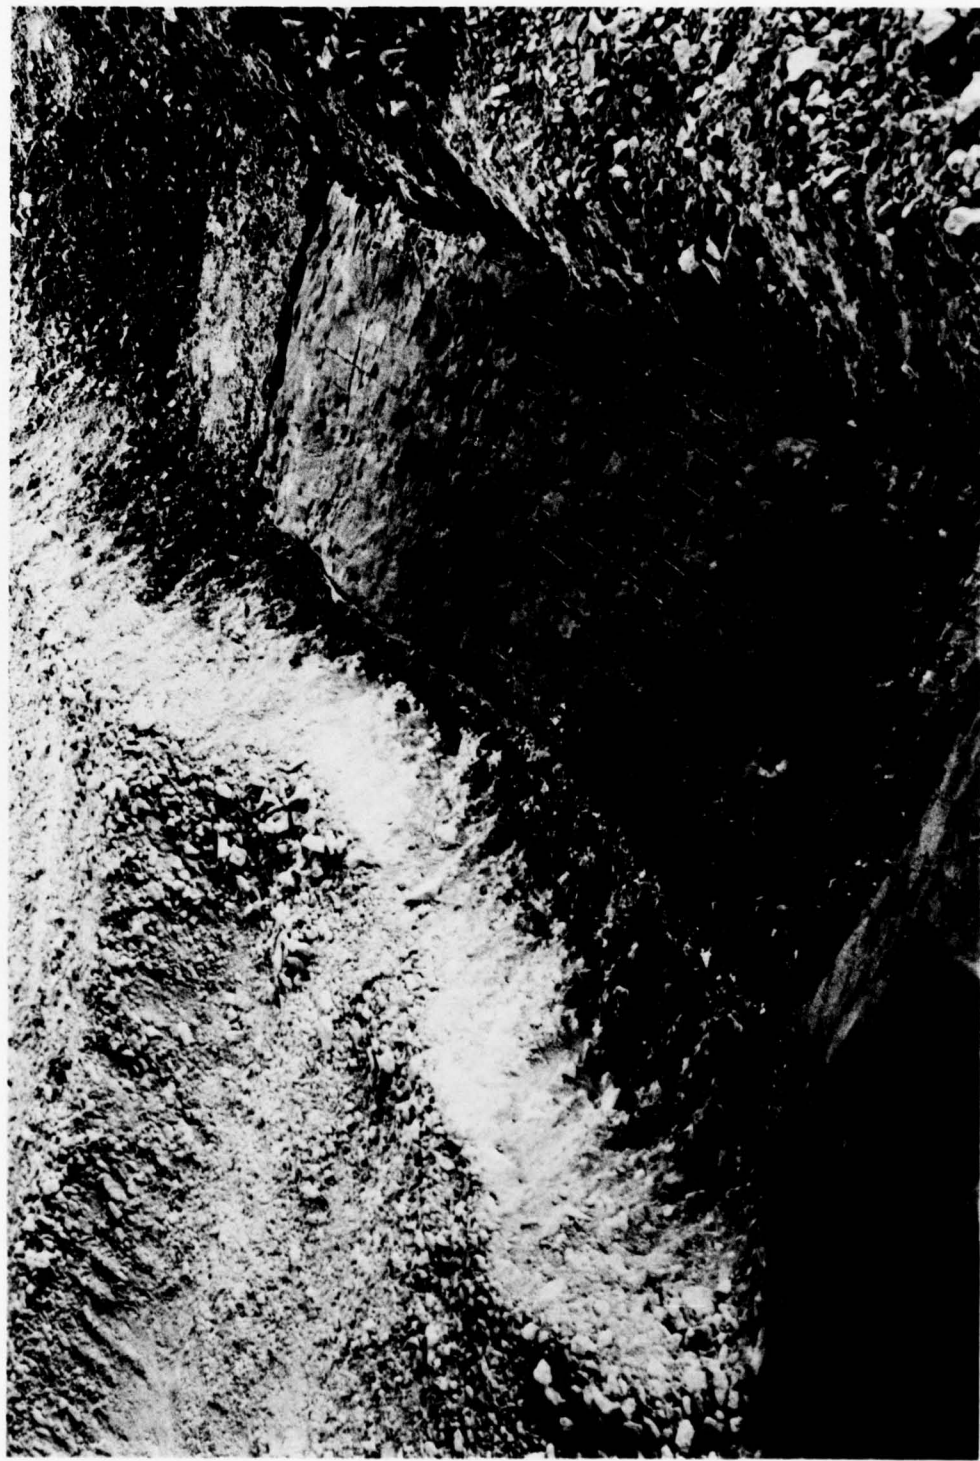
Photo 31. Wire embedded in subgrade of east wheel path of item 5 after 3661 coverages

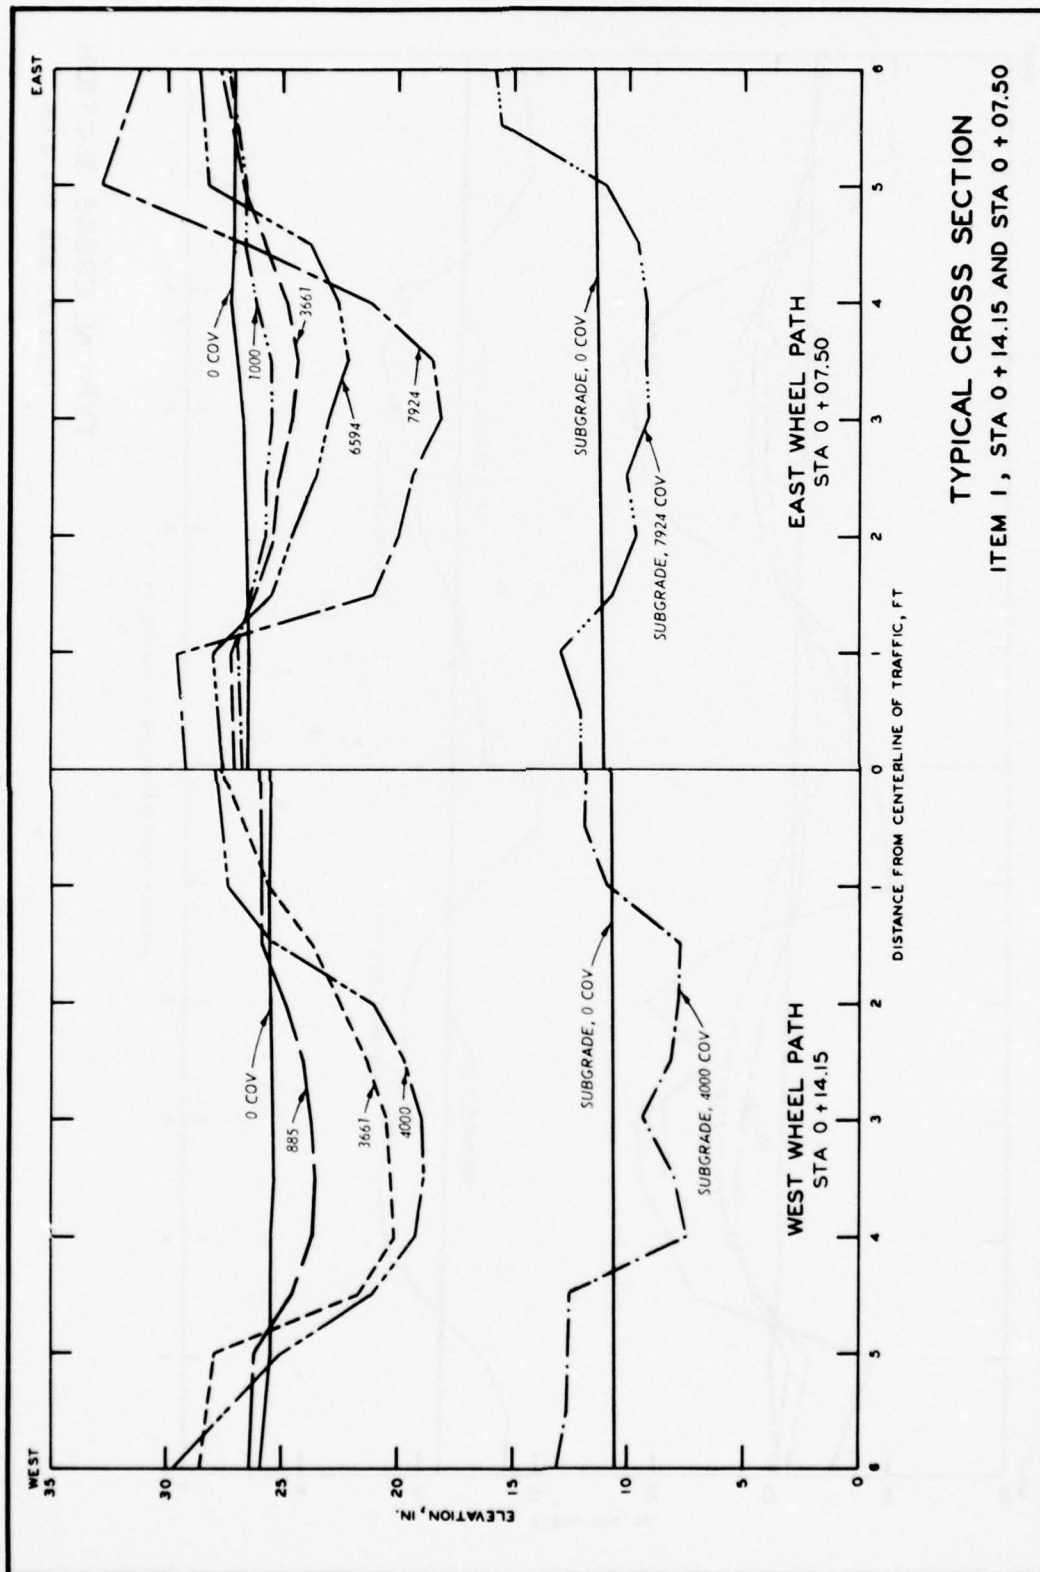
**TYPICAL CROSS SECTION**  
 ITEM 1, STA 0 + 14.15 AND STA 0 + 07.50

of the item was good with an average rut depth of 3.3 in.; however, after 3661 coverages, a spot failure started to develop in the west wheel path, and average rut measurements were 5.4 in. and 3.2 in. in the west and east wheel paths, respectively. At 3832 coverages, the average rut depth had increased to 8 in. in the west wheel path with the surface course shearing along the outer edges of the wheel path and breaking up and mixing with the sand from the underlying grid system. By 4000 coverages, an 11-in. rut had developed in the west wheel path, but the average rut depth for the east wheel path was only 3.6 in. (Photo 14). Traffic was allowed to continue over the west wheel path for 50 additional coverages before repairs were made. Photo 15 shows a closeup view of the damage that resulted in the west wheel path. After a test trench was excavated and backfilled in the west wheel path, traffic was continued to monitor performance in the east wheel path. The rut depth increased with additional traffic to an average of 4.8 in. at 5203 coverages and 5.9 in. at 6594 coverages. After this coverage level, a spot failure developed, and an 11-in. rut resulted at 7924 coverages (Photo 16). Plate 3 shows a typical cross section for the item at different coverage levels.

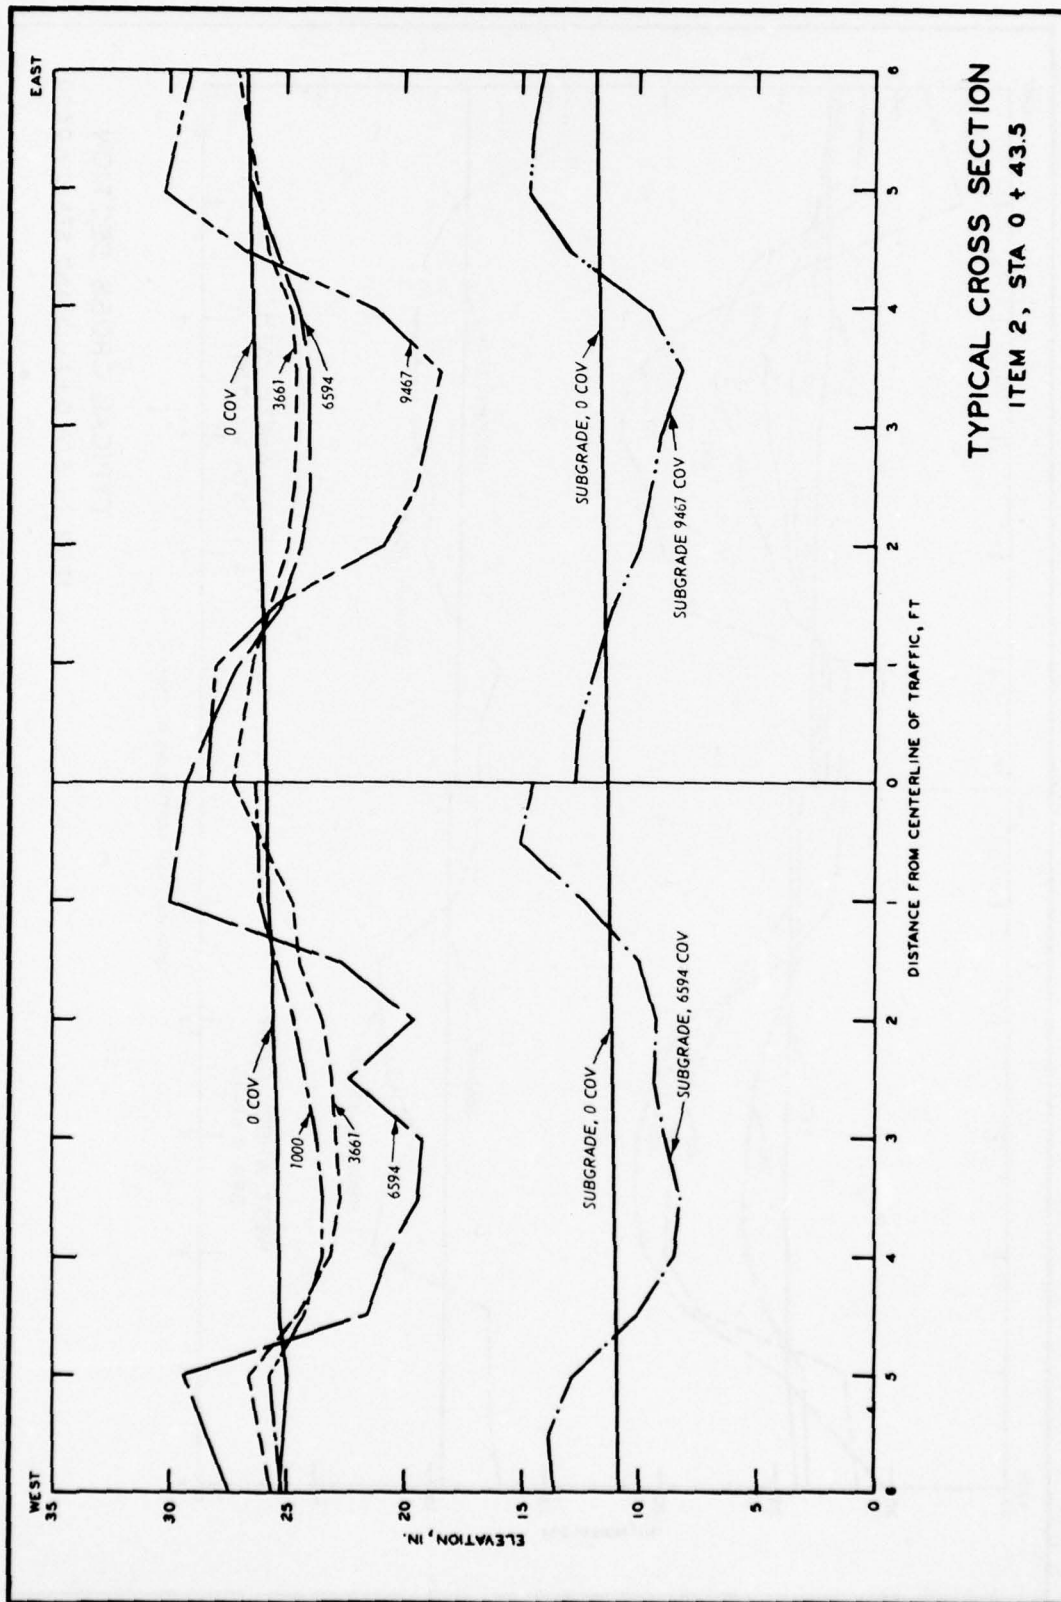
TYPICAL CROSS SECTION  
ITEM 2, STA 0 + 43.5

33. The crushed stone wearing course and the grid layers were in the same condition after traffic as were the course and grid layers in item 1. The T-16 membrane between the subgrade and the bottom grid layer had several small cuts made by the aluminum grids. The membrane increased performance of this item by approximately 2000 coverages over that of item 1. Typical cross-section data for this item are shown in Plate 4.

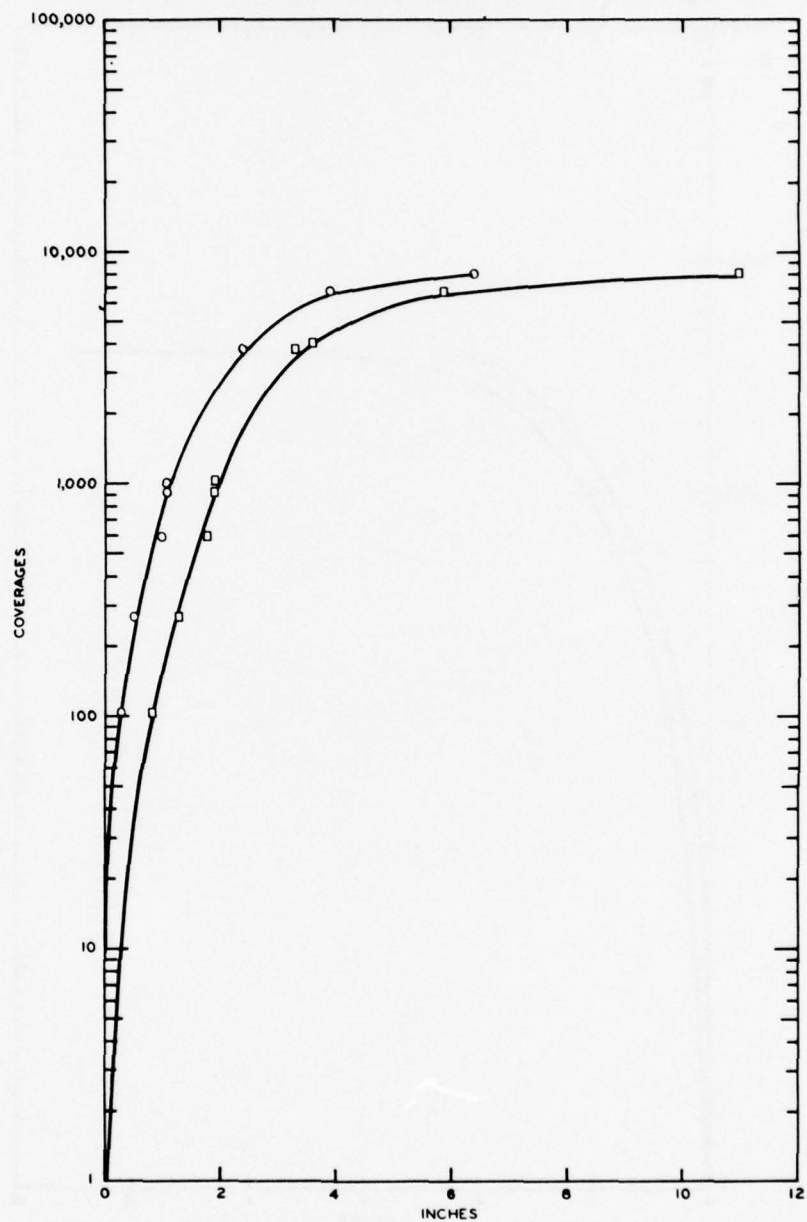
**COVERAGES VERSUS PERMANENT  
SURFACE DEPRESSION AND  
RUT DEPTH  
ITEM 1, EAST WHEEL PATH**

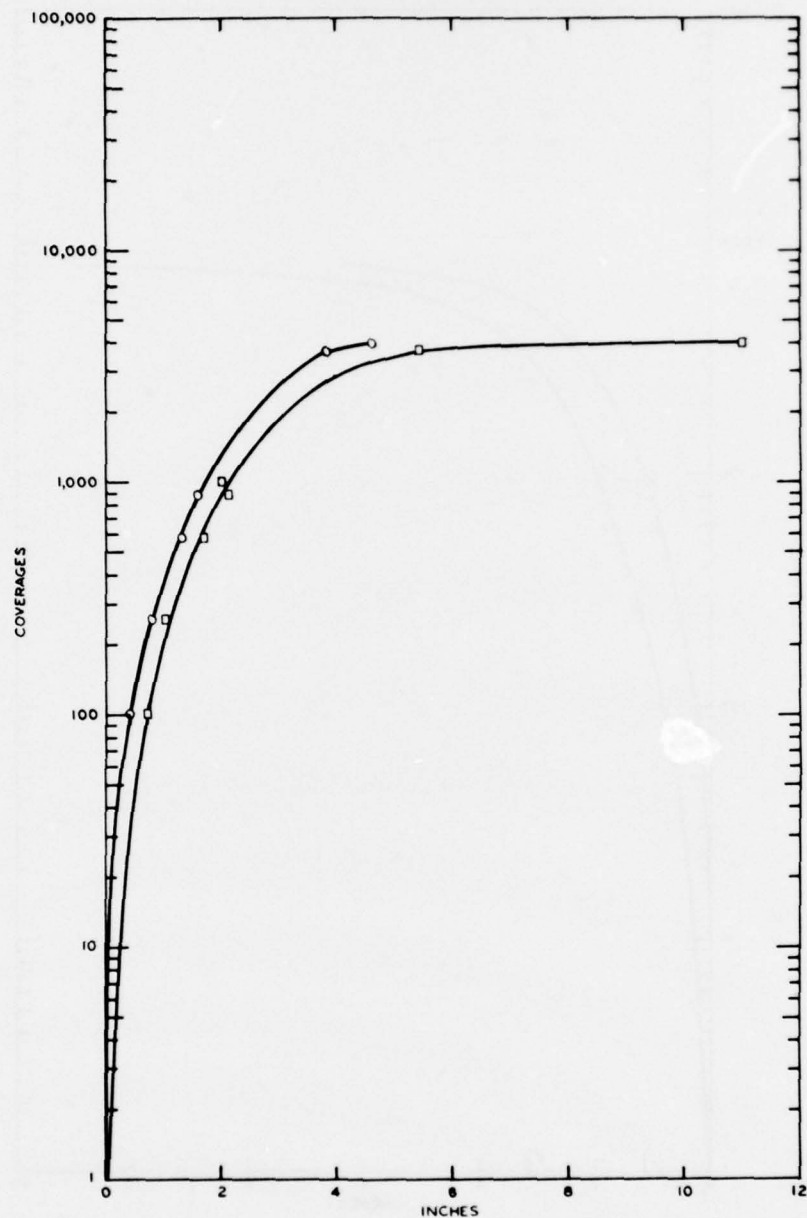
**COVERAGES VERSUS PERMANENT  
SURFACE DEPRESSION AND  
RUT DEPTH  
ITEM 1, WEST WHEEL PATH**

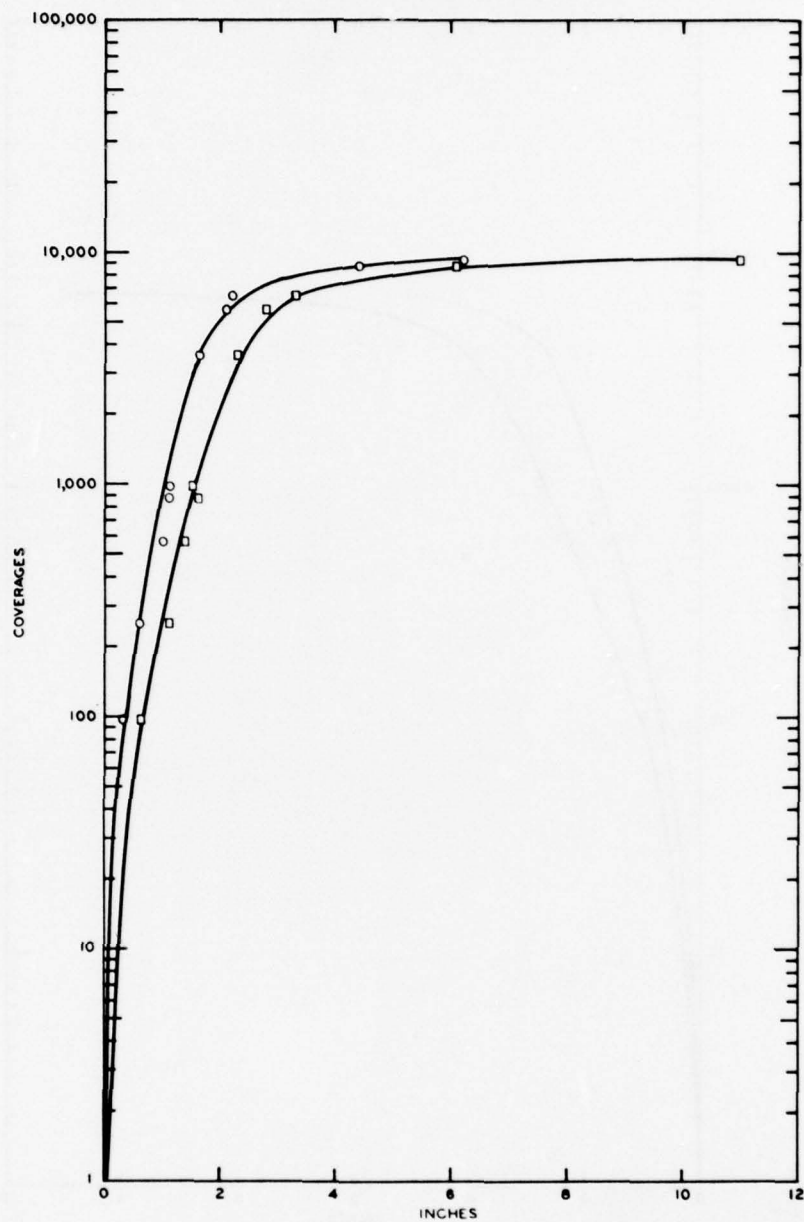
**COVERAGES VERSUS PERMANENT  
SURFACE DEPRESSION AND  
RUT DEPTH  
ITEM 2, EAST WHEEL PATH**

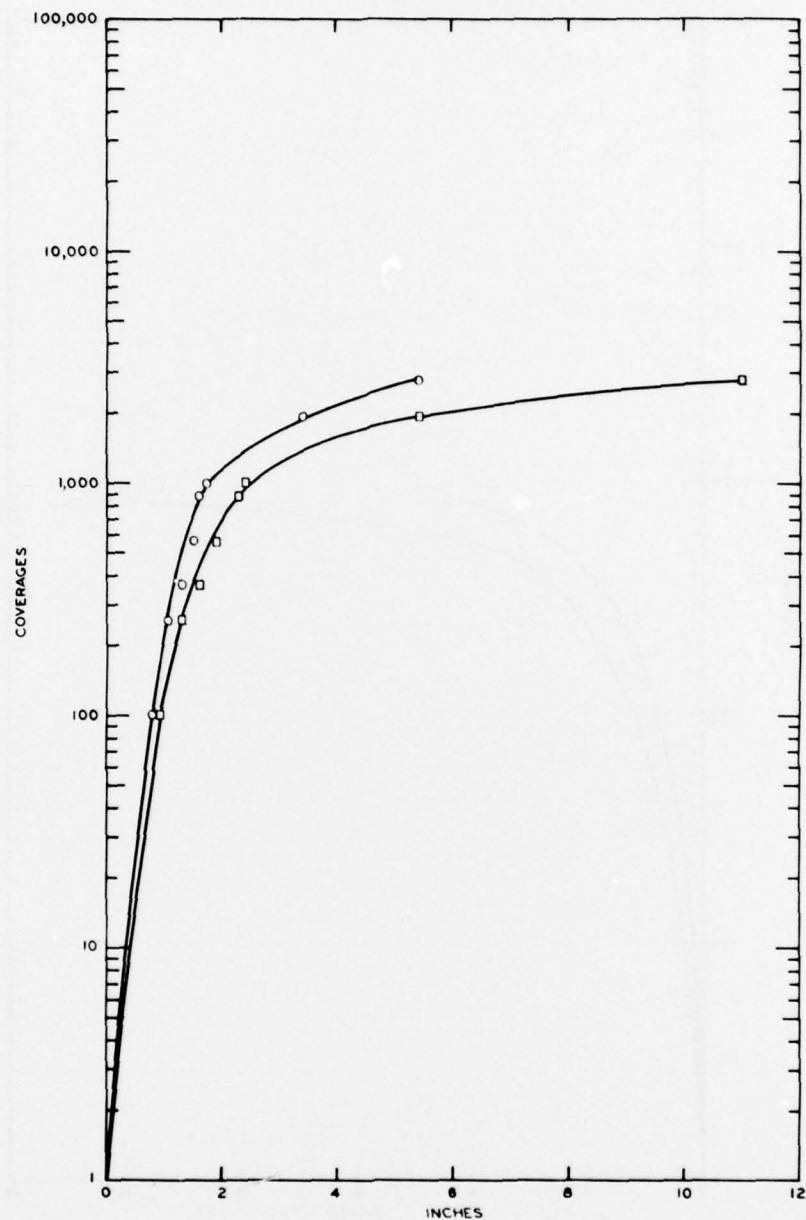
**COVERAGES VERSUS PERMANENT  
SURFACE DEPRESSION AND  
RUT DEPTH  
ITEM 3, EAST WHEEL PATH**

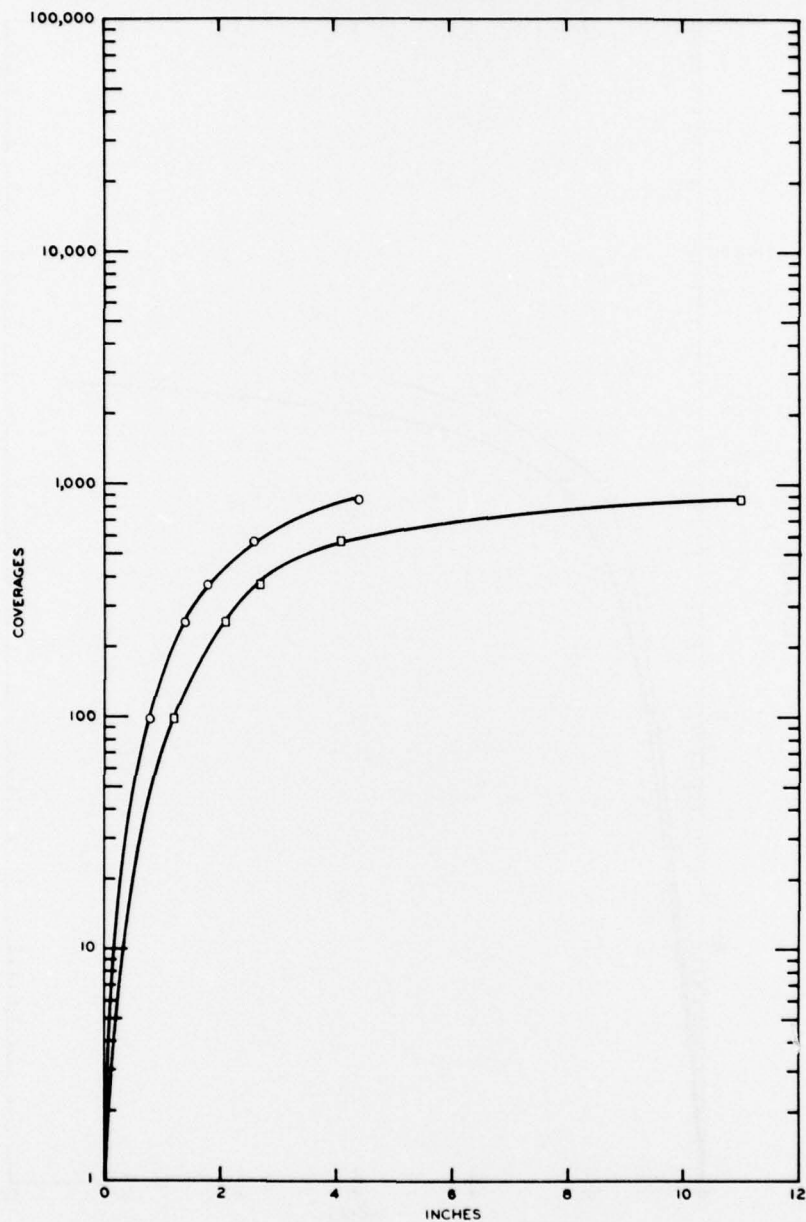
**COVERAGES VERSUS PERMANENT  
SURFACE DEPRESSION AND  
RUT DEPTH  
ITEM 3, WEST WHEEL PATH**

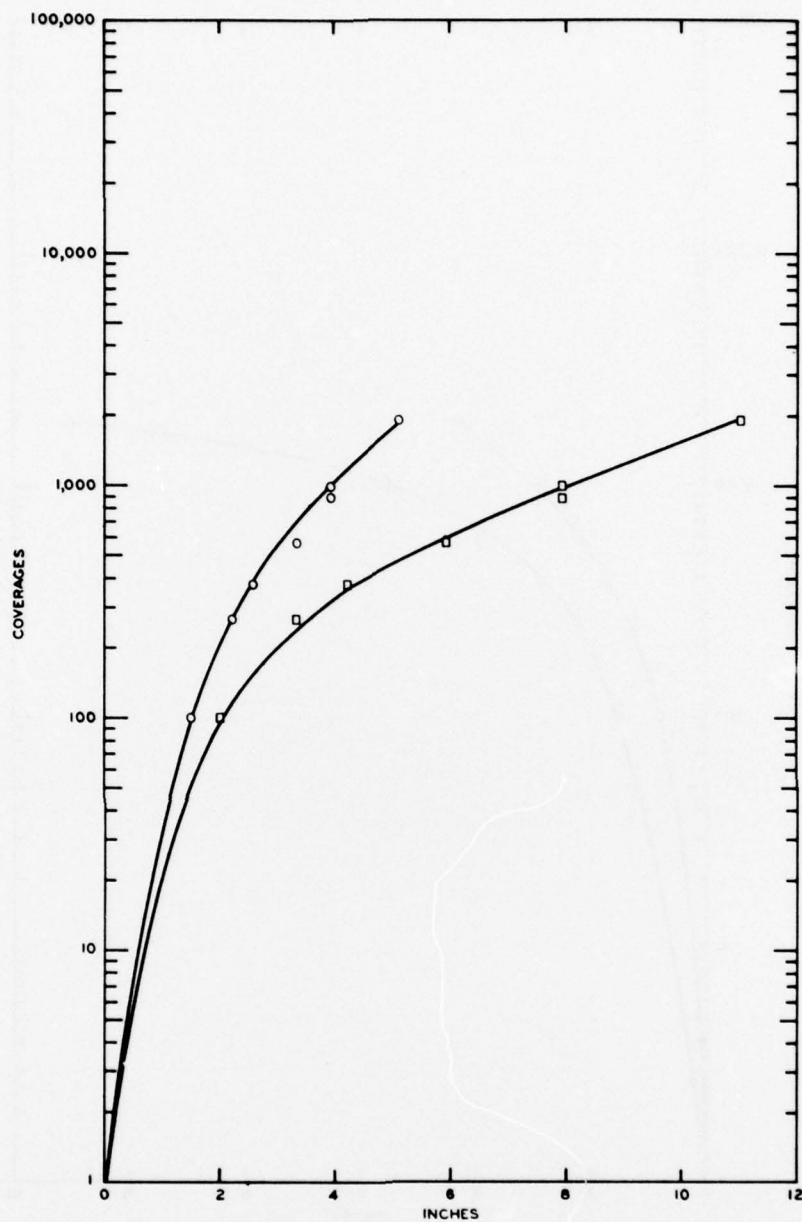
**COVERAGES VERSUS PERMANENT  
SURFACE DEPRESSION AND  
RUT DEPTH  
ITEM 4, EAST WHEEL PATH**

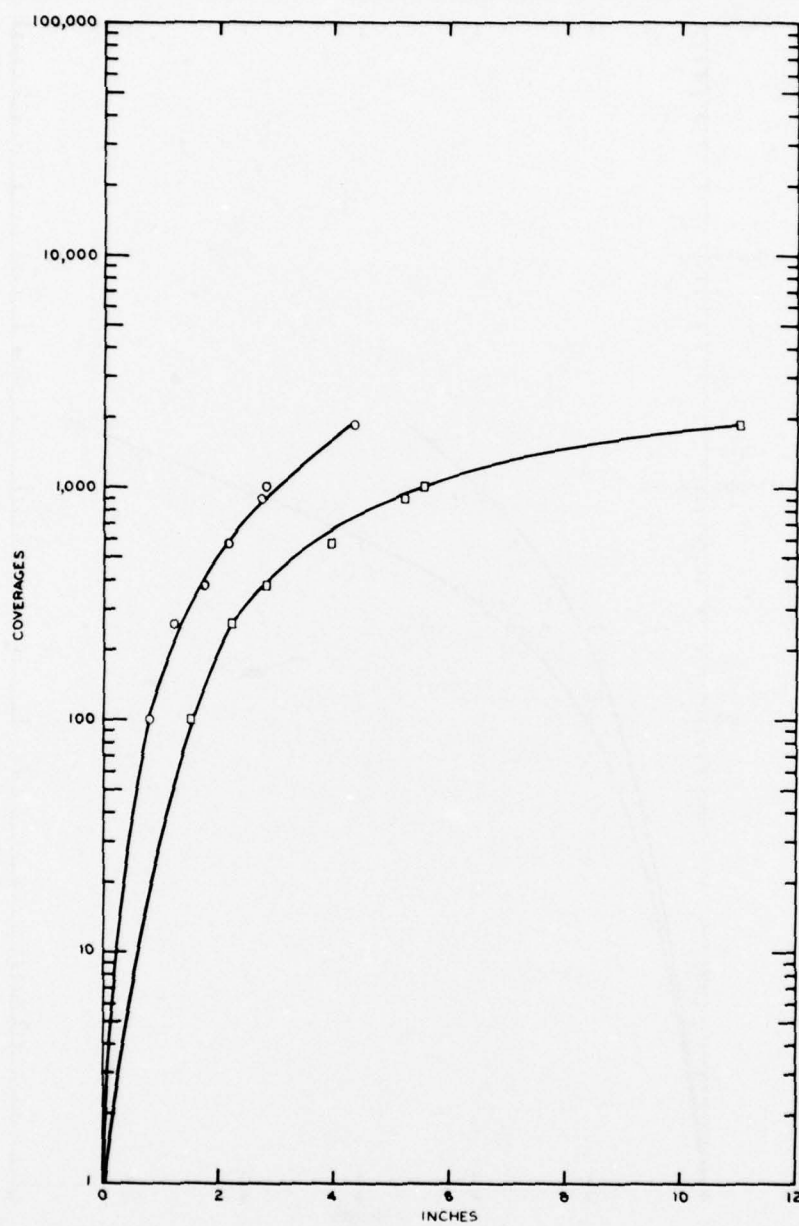
**COVERAGES VERSUS PERMANENT  
SURFACE DEPRESSION AND  
RUT DEPTH  
ITEM 4, WEST WHEEL PATH**

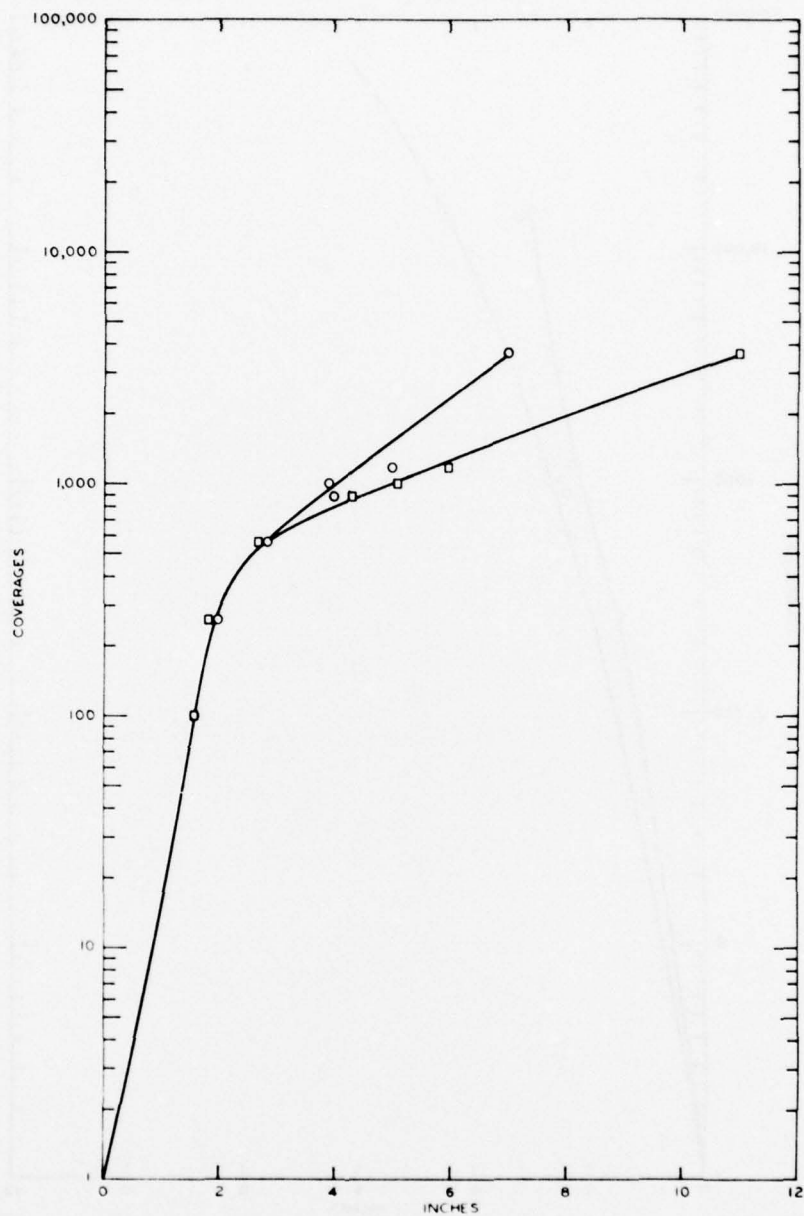
**COVERAGES VERSUS PERMANENT  
SURFACE DEPRESSION AND  
RUT DEPTH  
ITEM 5, EAST WHEEL PATH**

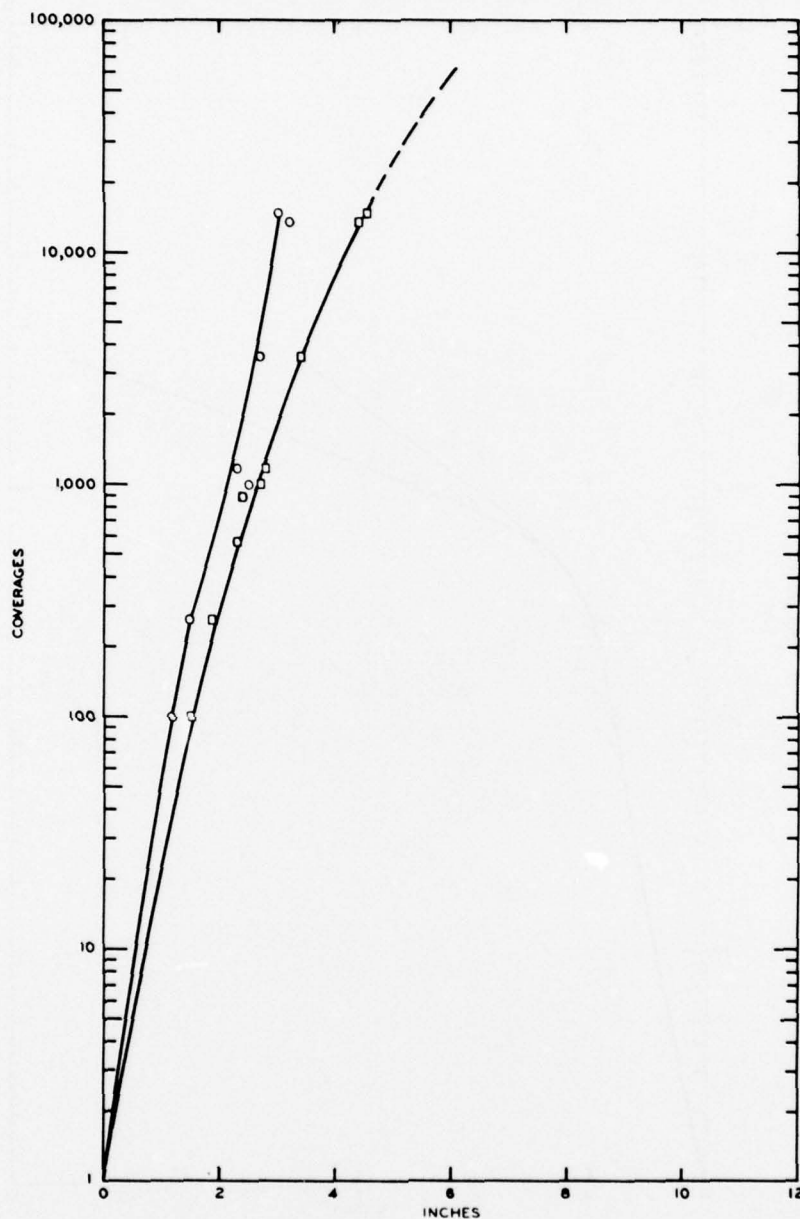
**COVERAGES VERSUS PERMANENT  
SURFACE DEPRESSION AND  
RUT DEPTH  
ITEM 5, WEST WHEEL PATH**

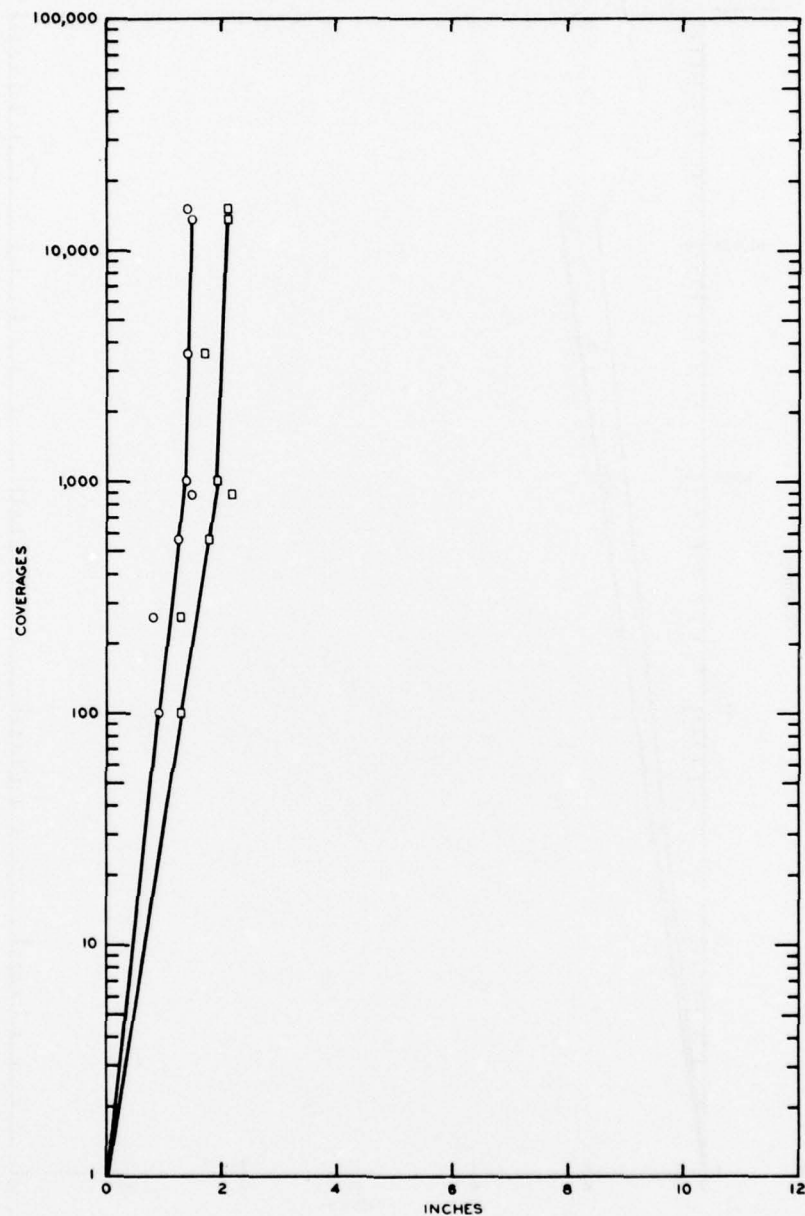
**COVERAGES VERSUS PERMANENT  
SURFACE DEPRESSION AND  
RUT DEPTH  
ITEM 6, EAST WHEEL PATH**

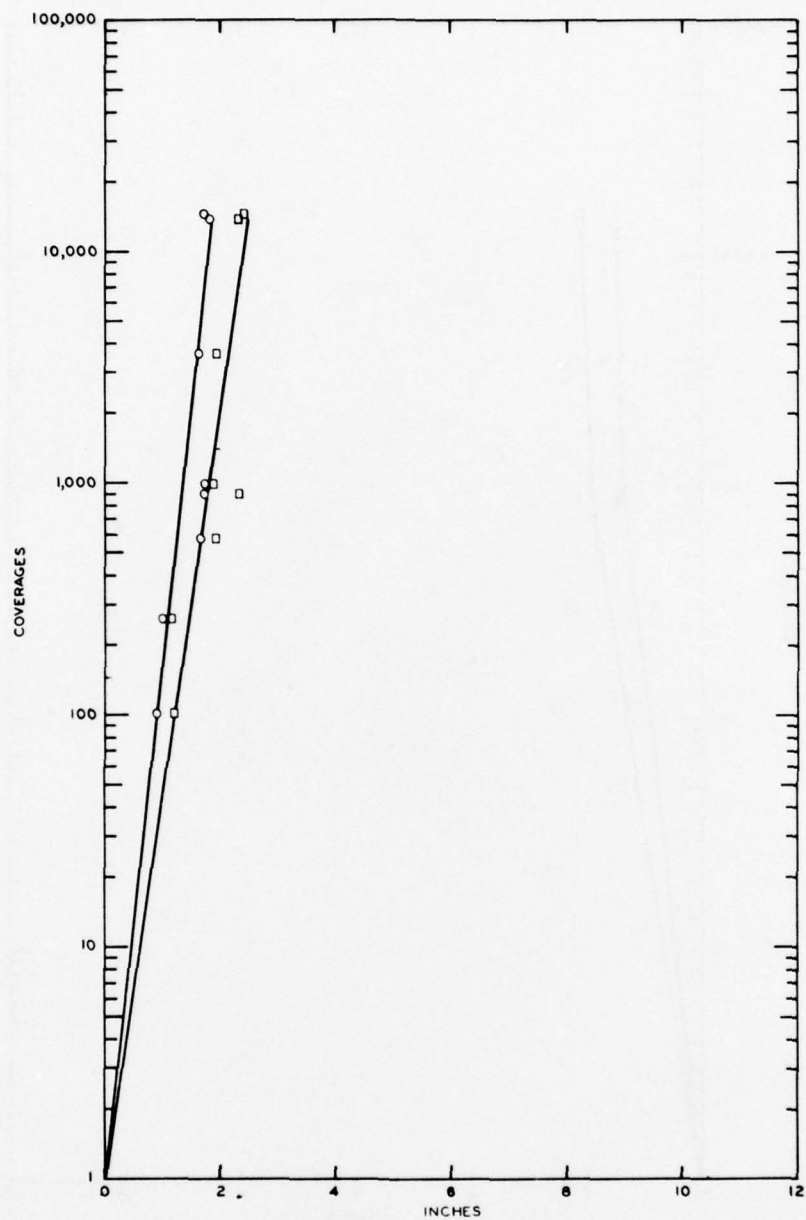
**COVERAGES VERSUS PERMANENT  
SURFACE DEPRESSION AND  
RUT DEPTH  
ITEM 6, WEST WHEEL PATH**
